Effects of via-conductor geometry in the electromigration failure of Al:Cu wires

R. Leon, D. Vu, A.S. Johnson, R. Ruiz, J. Okuno, J. Uribe, and G. Hather
*Jet Propulsion Laboratory, California Institute of Technology, 4800 Oak Grove Drive,
Pasadena, CA 91109*

J. R. Lloyd
*IBM Research Division, Thomas J. Watson Research Center, Yorktown Heights, NY
10598*

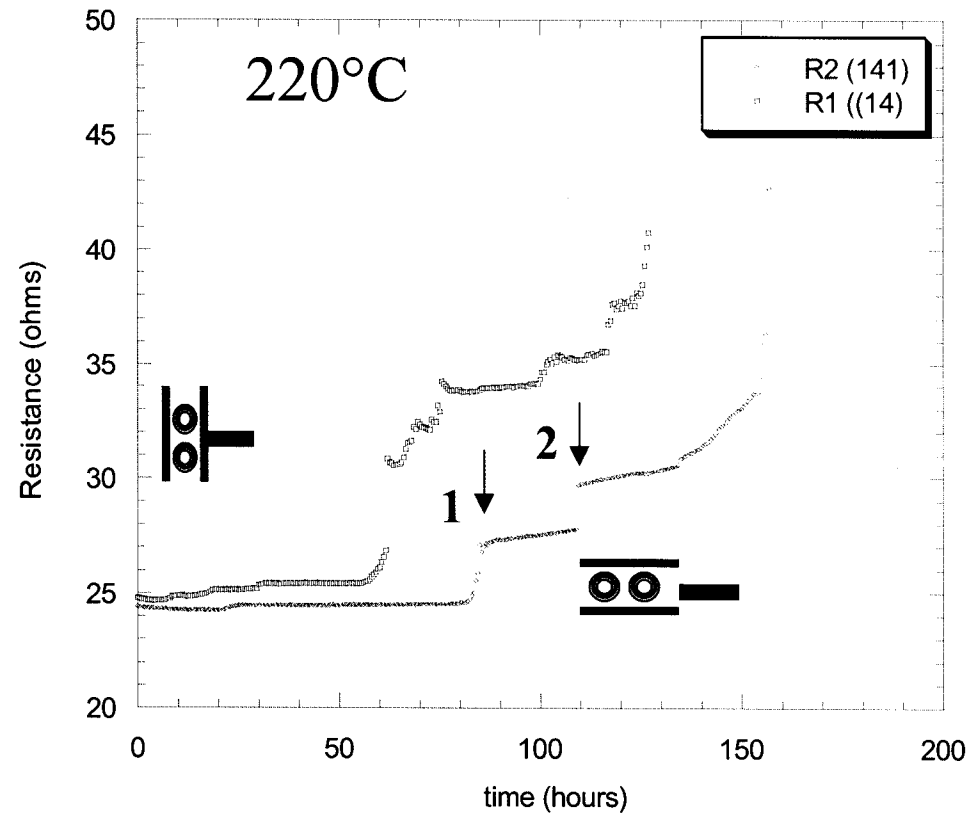
Proposed mechanism to explain
“steps” in colinear geometry.
Progressive void formation at each
plug/conductor interface could
explain measured resistance data.

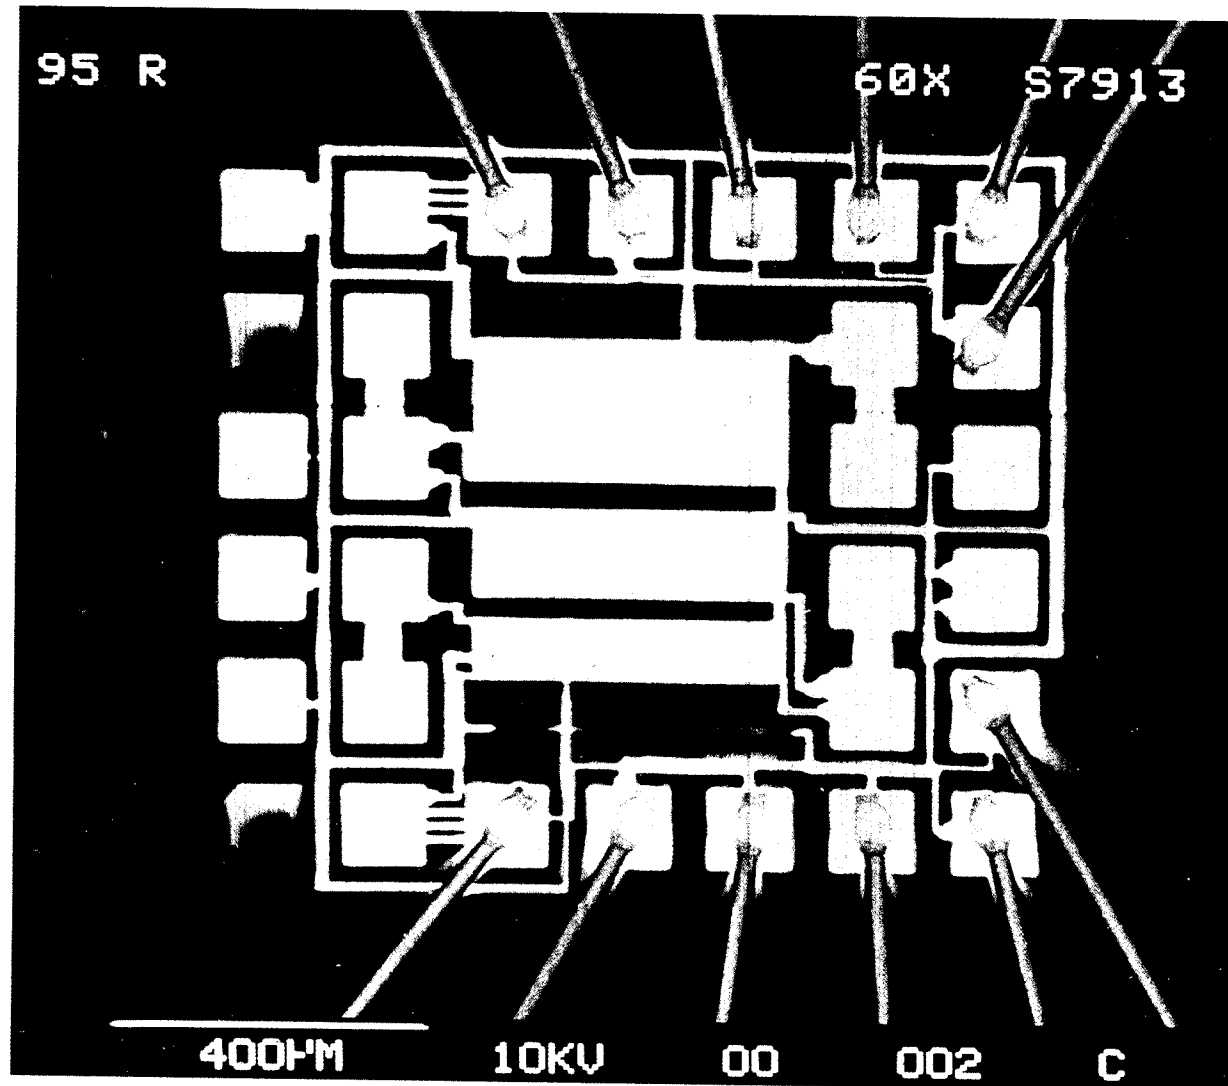
Image shows EBIC contrast when there are no open conductors.

Failure point cannot be seen in plan-view (top) imaging even for an open circuit failure after electromigration testing.

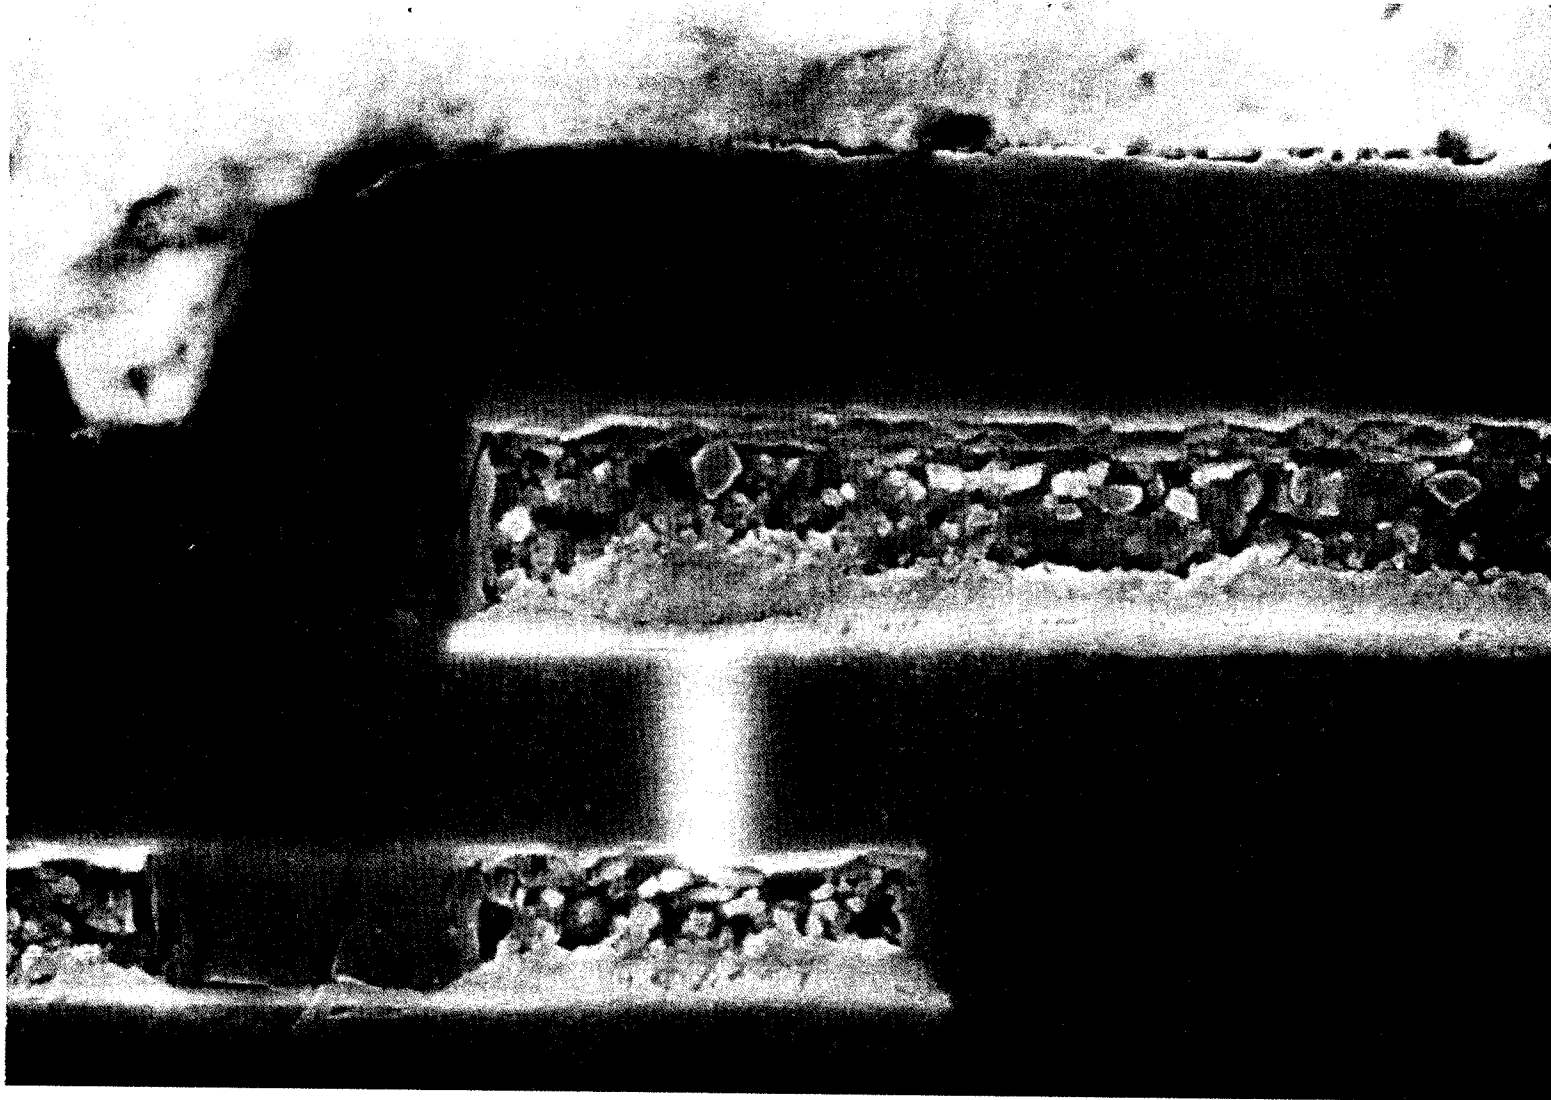
Cross sectional SEM image of a “good” structure prior to EM testing, which shows one of the Tungsten plugs.
